Reliability of SiC power MOSFETs

Erick Romo-Mendoza^{1,2}, Alon Vardi², Jesús A. del Alamo²

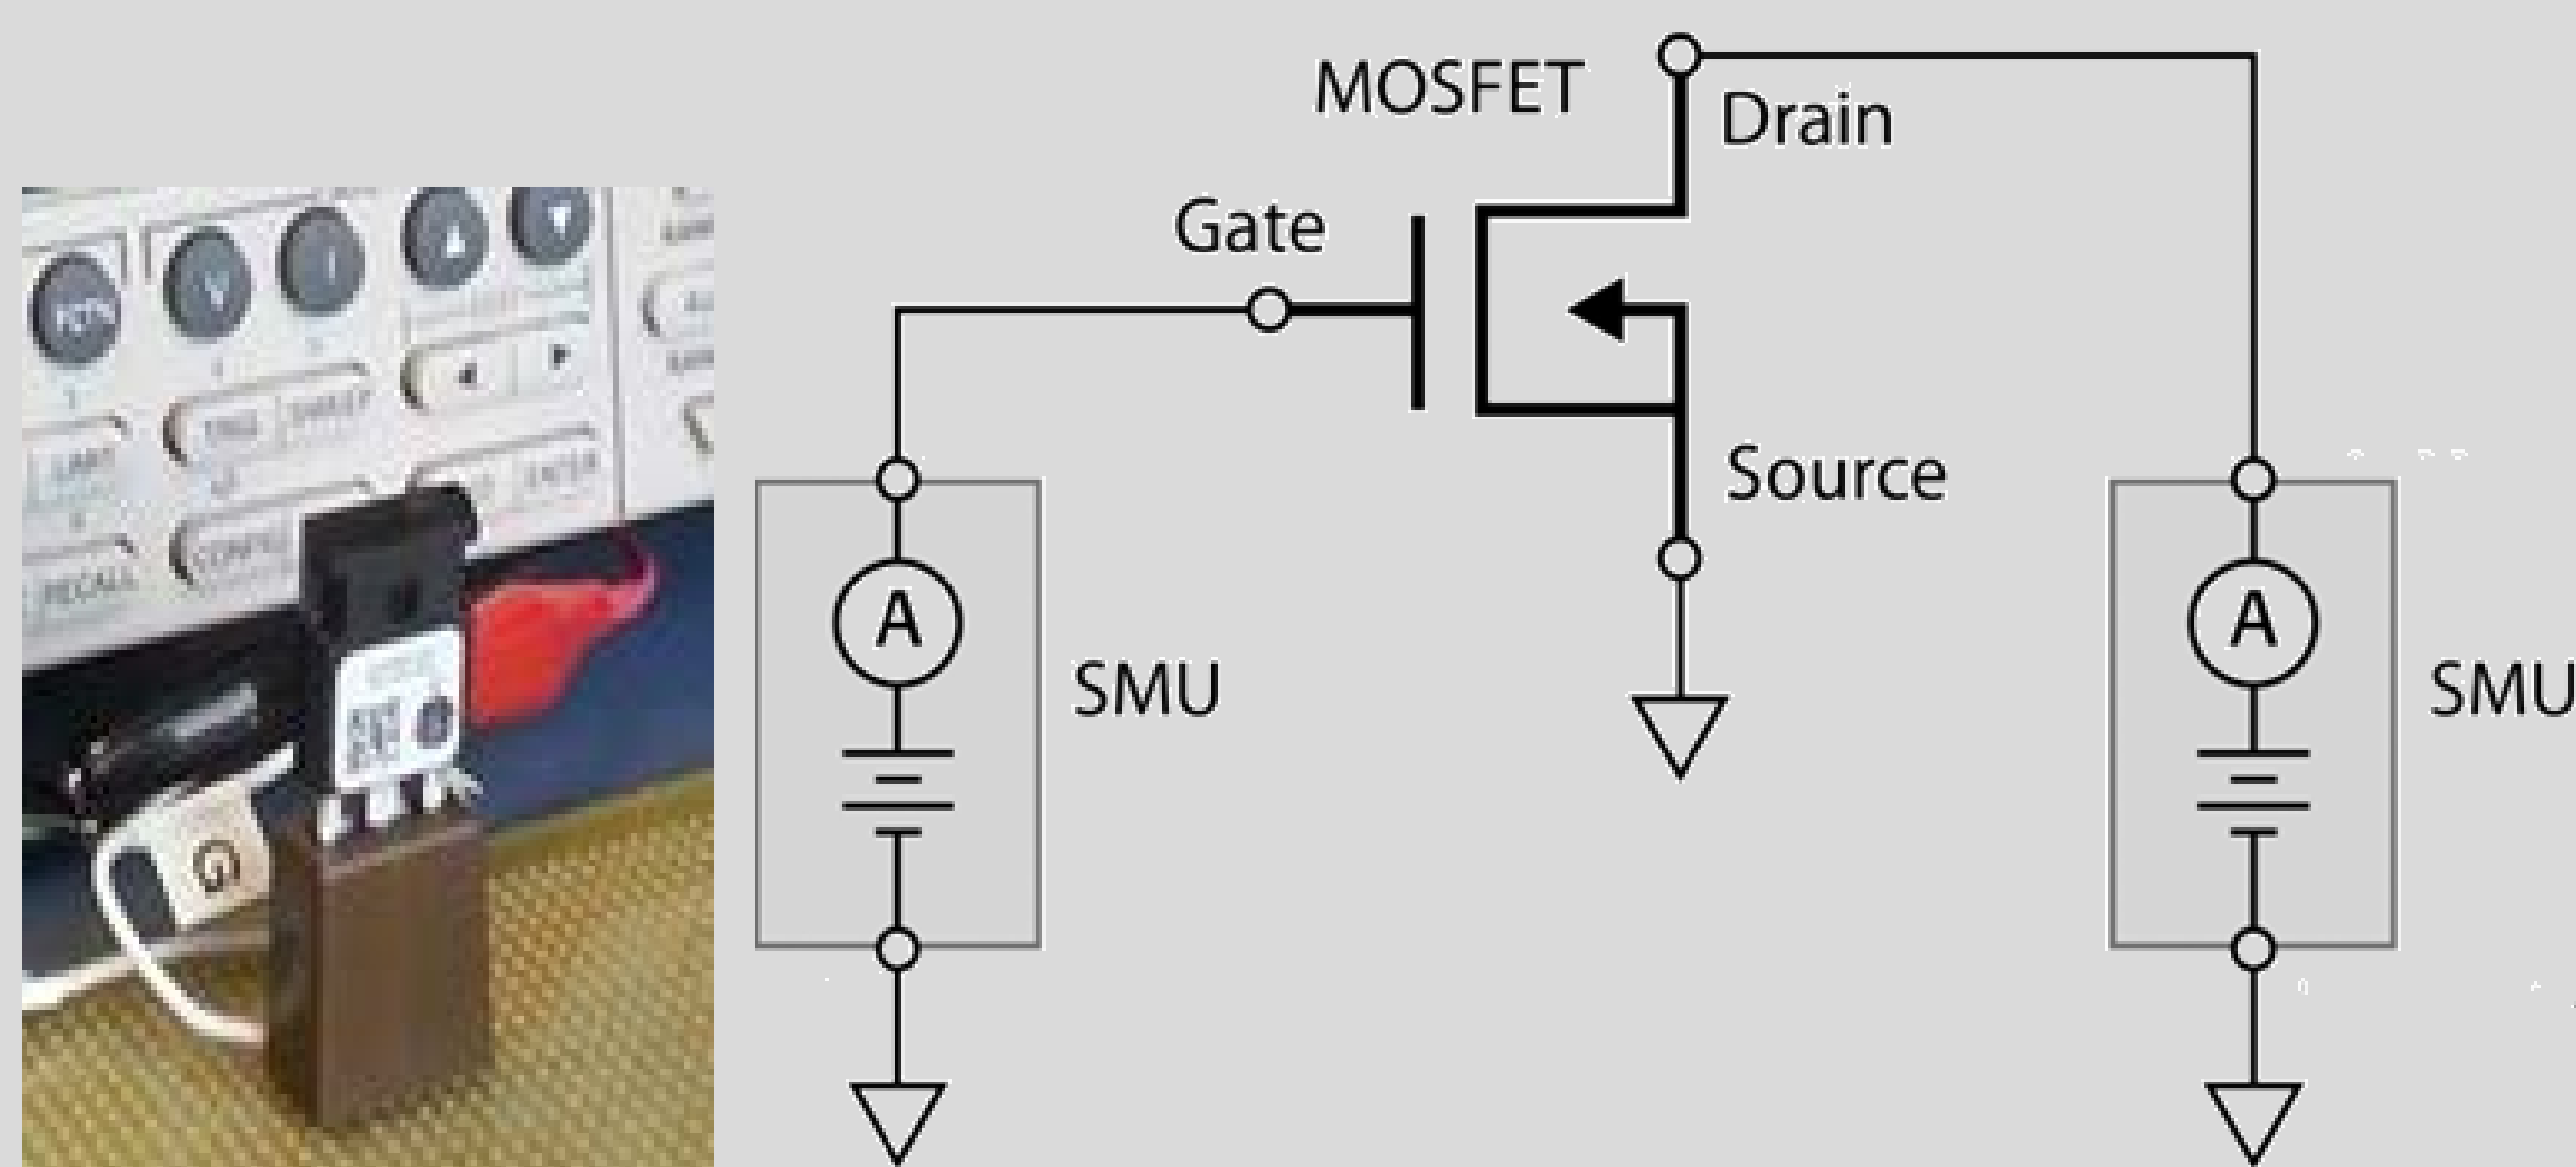
Figure 1. (Left) SiC power MOSFET in a Transistor Outline (TO) package. The device can hold up to 1200V V_{ds} and 20A I_{ds} . (Right) Circuit diagram of stress system for MOSFET testing.

A measurement system was developed in order to characterize and stress the transistor up to 200 V and 100 mA.

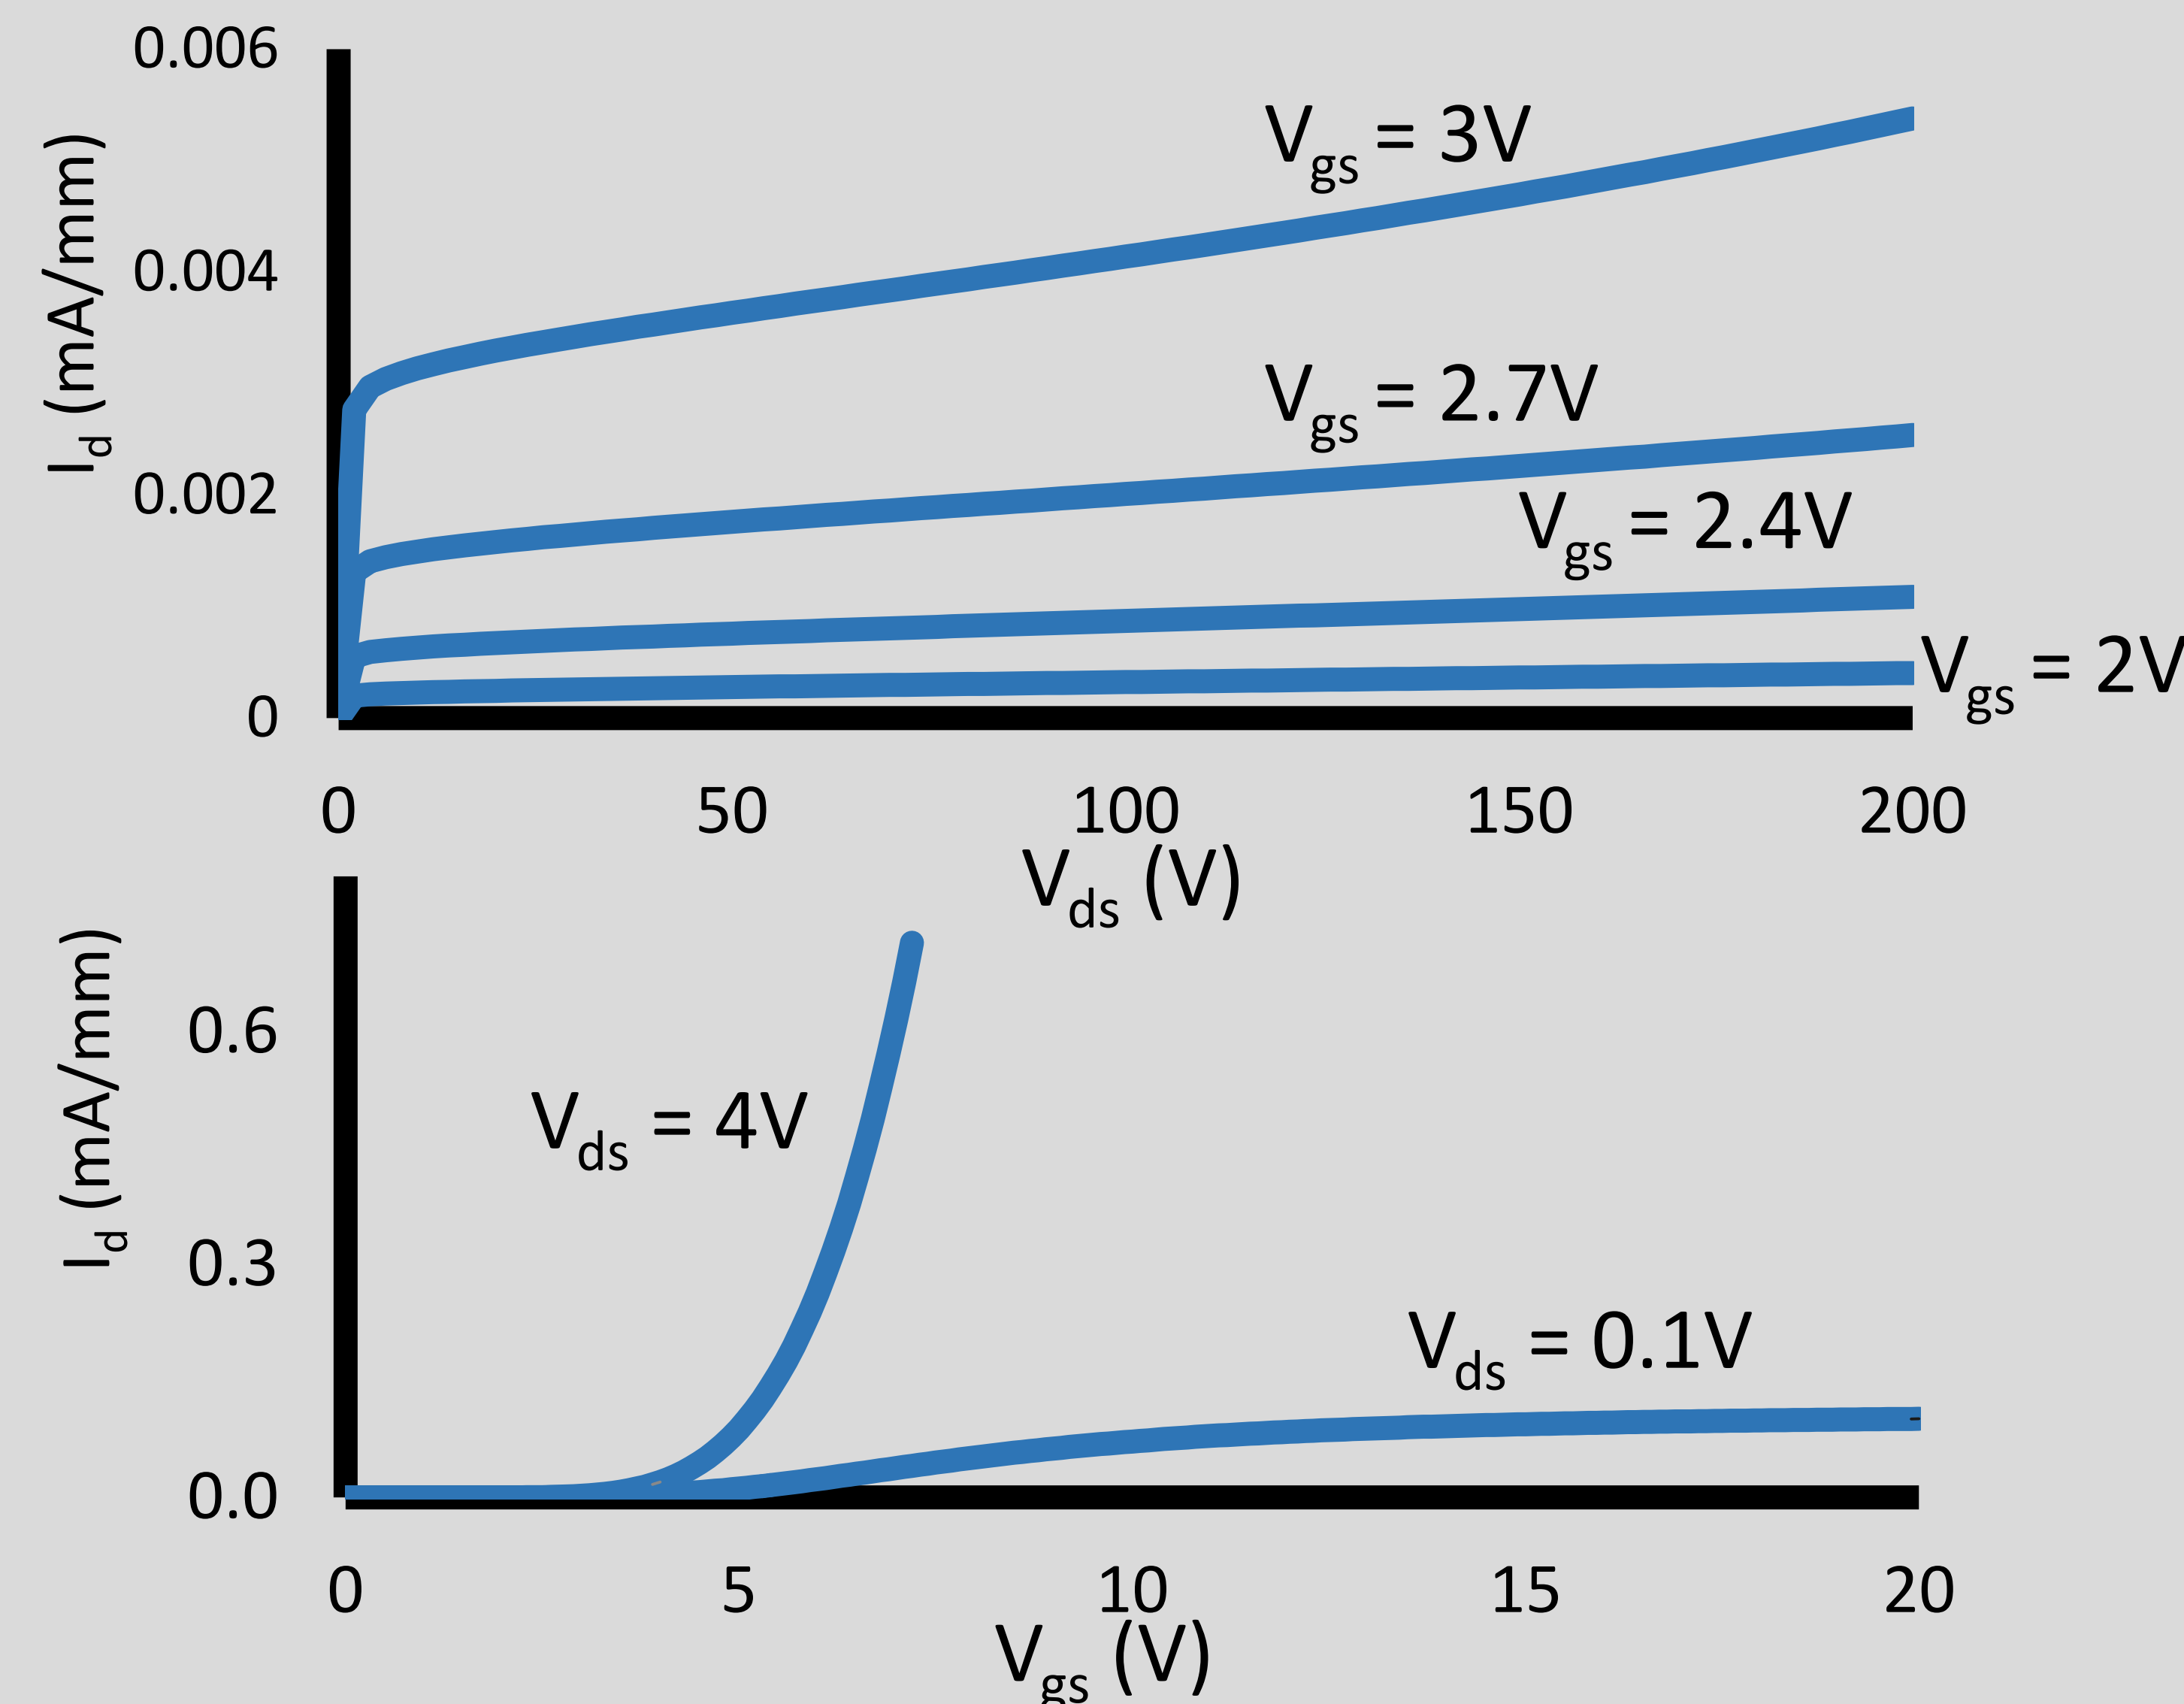
Figure 2. Output (up) and Transfer (down) characteristics of a virgin SiC MOSFET, as obtained in our measurement system.

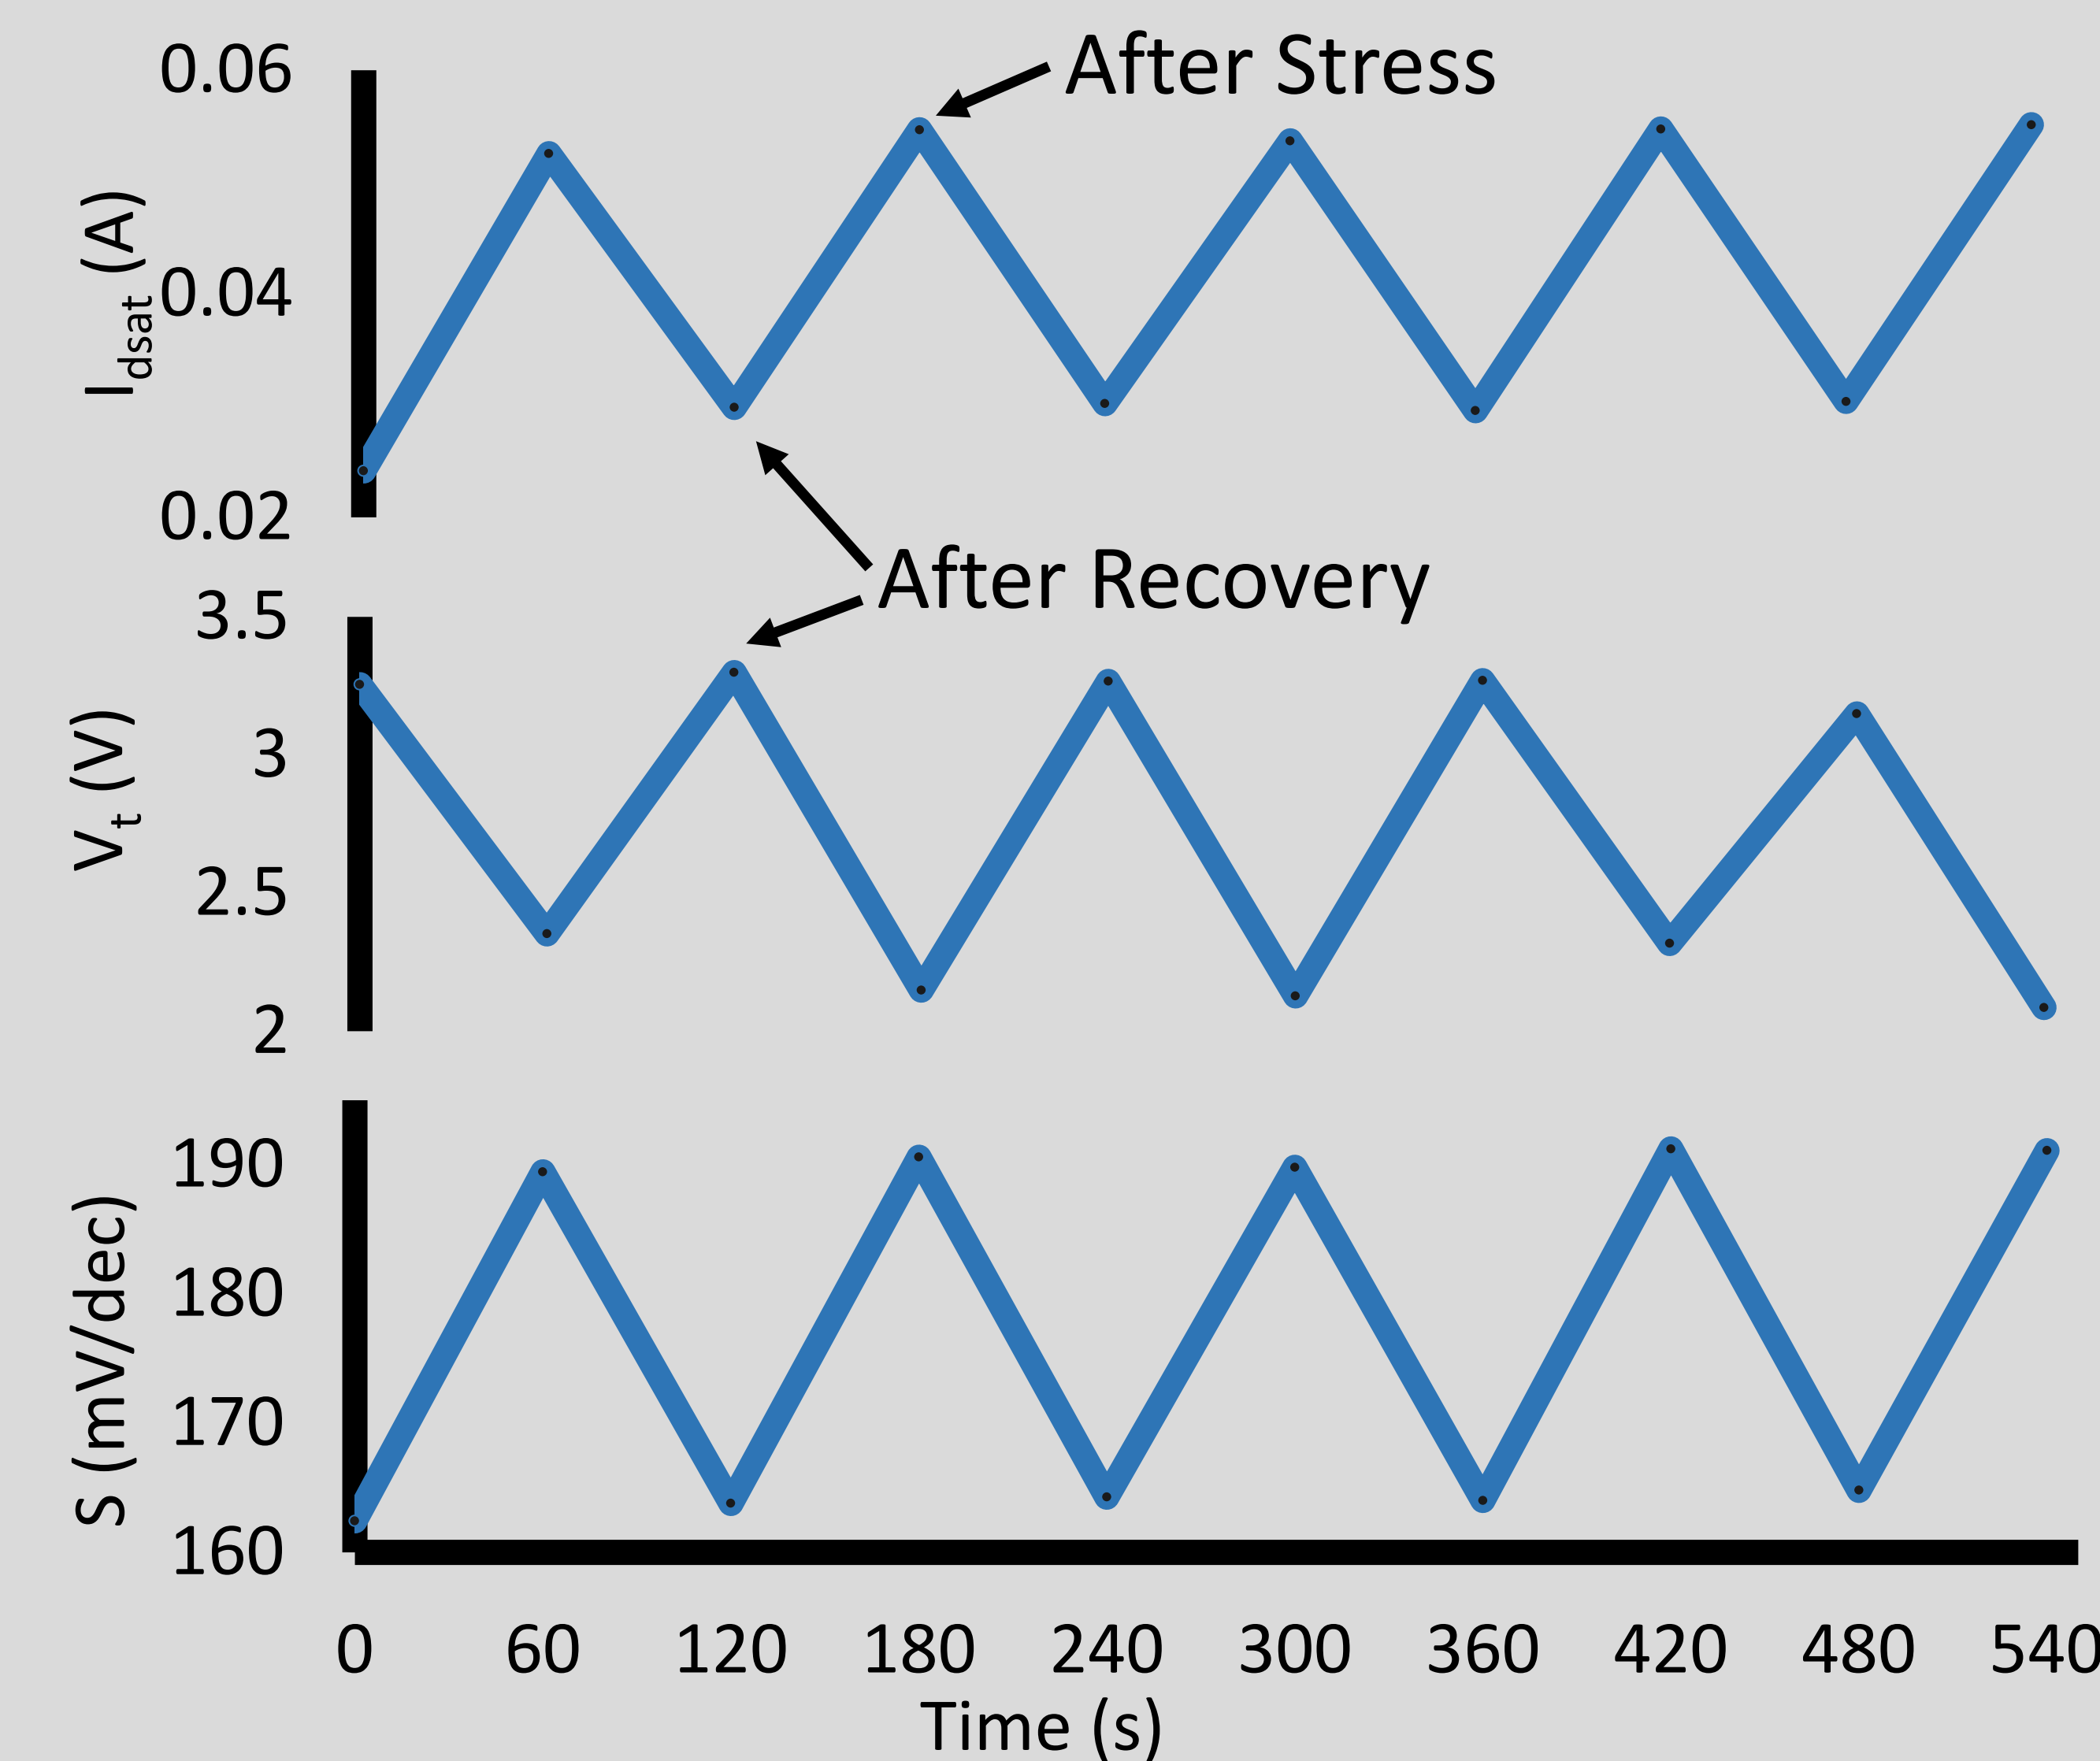
Figure 3. Device FOM during typical stress test consist of 5 cycles of 1 minute stress of $V_{gs} = 4V$ and $V_{ds} = 200V$ and 1 minute of recovery. (top) Current Saturation (middle) threshold voltage and (bottom) subthreshold swing.

The positive bias stress causes a negative shift in V_t and consequently I_{dsat} increases. The fact that the degradation is fully recoverable suggest that the observed degradation is due to carrier trapping. In addition, the degradation in S suggests that part of the traps are at the Oxide-Semiconductor interface.

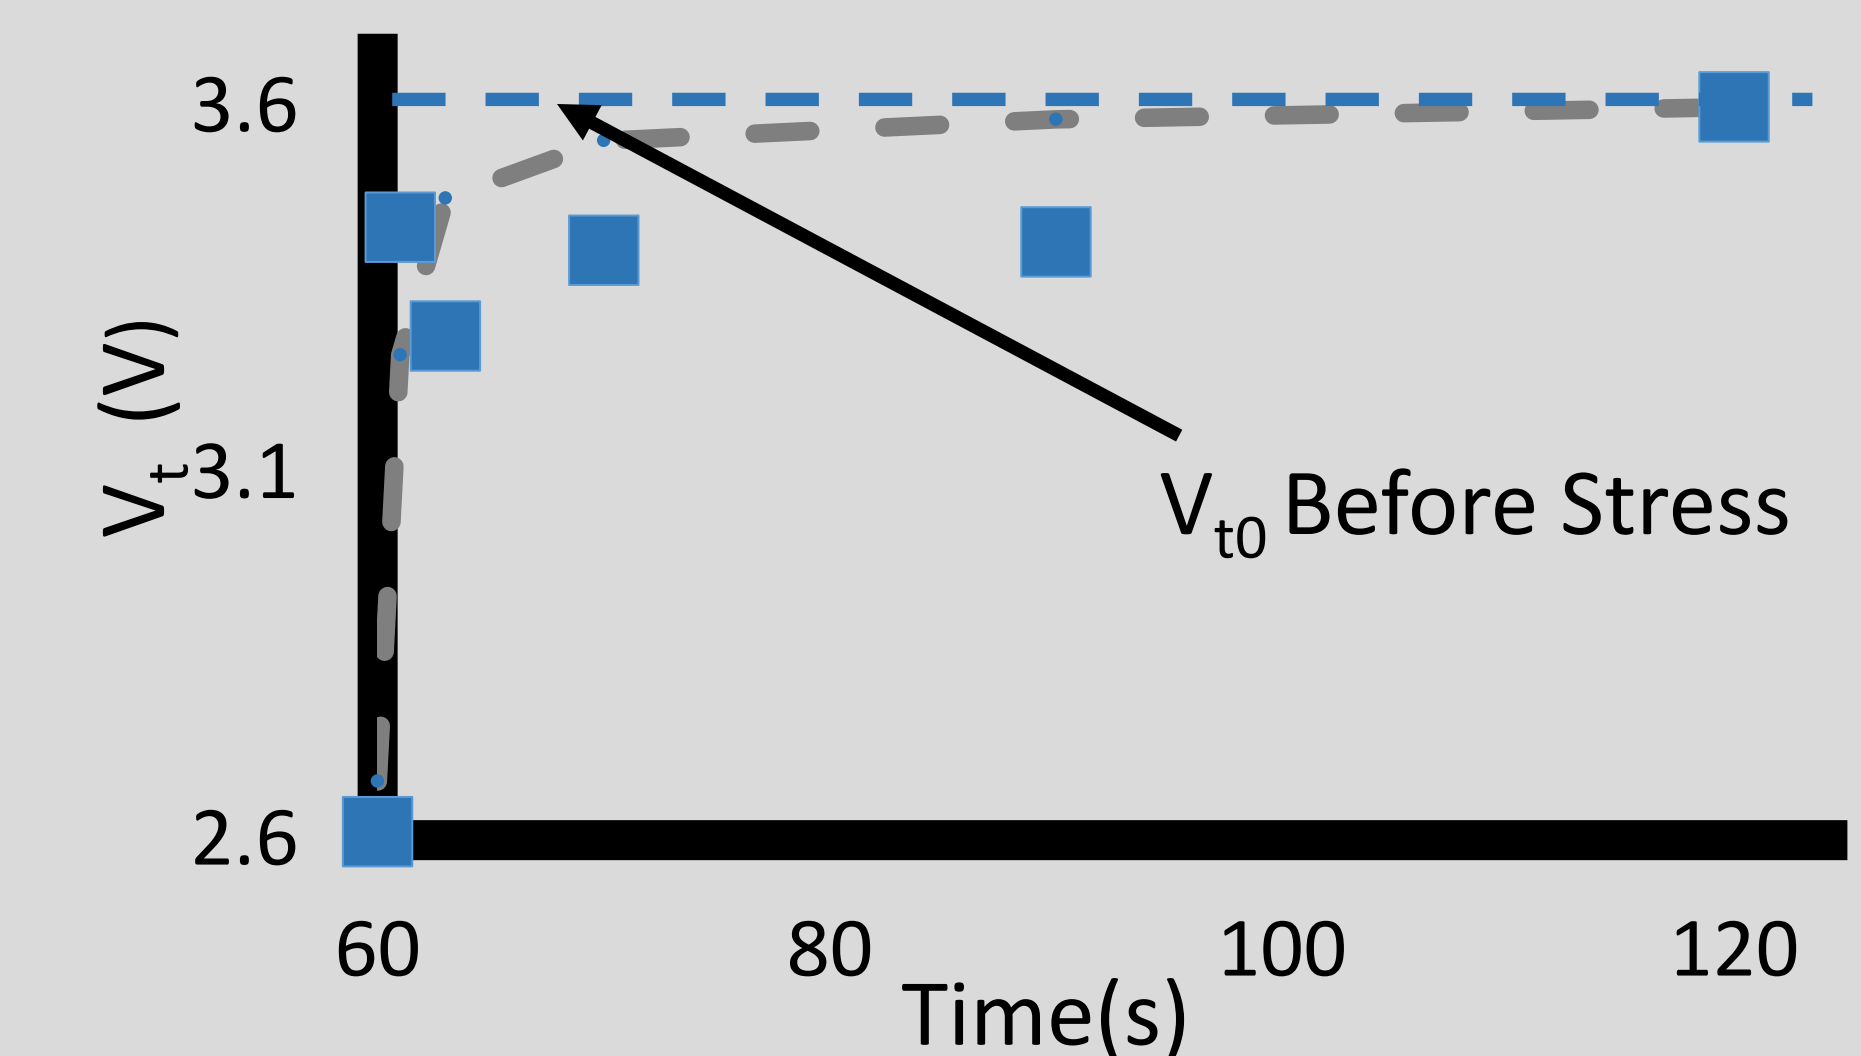
Figure 4. Recovery time of threshold voltage after 1 minute of stress applied. Gray dashed line – exponential fit of data.

FOM	Degradation (%)	Recovery Time (s)
V_t	35%	49
S	16%	50
I_{sat}	150%	30

Table 1. Degradation of the device in percentages after 1 minute of stress and its full recovery time.
